**Report on Preliminary Site Investigation  
(Contamination)**

**Gosford Waterfront Revitalisation  
Masterplan**

**Gosford Waterfront, Central Coast  
Highway, Gosford NSW**

**Project 225005.00**

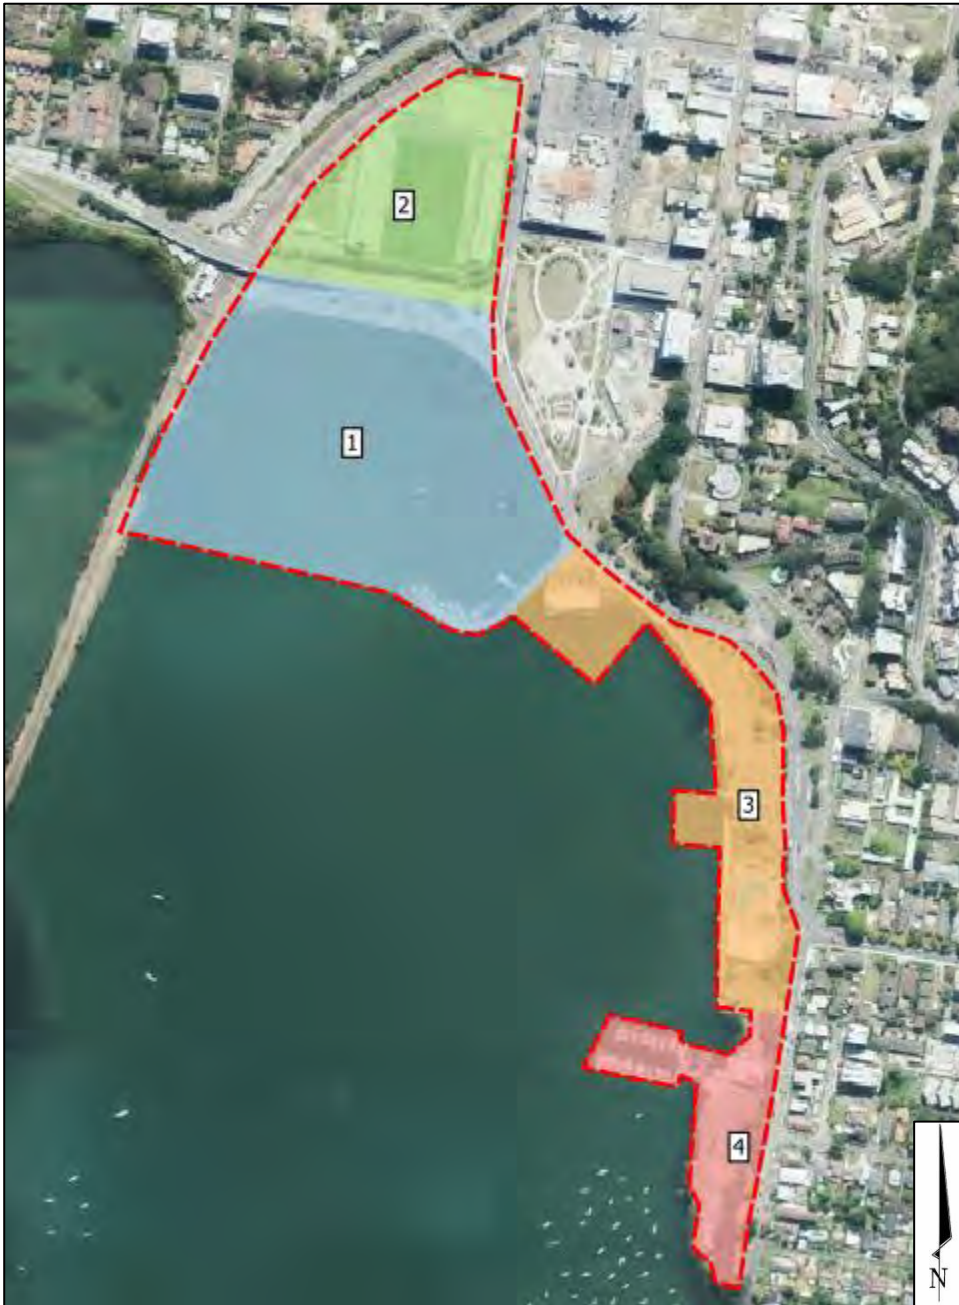
**Figure 4: Site boundary (red dotted line) and Precincts 1 to 4. Aerial image sourced from MetroMap (12 September 2022).**

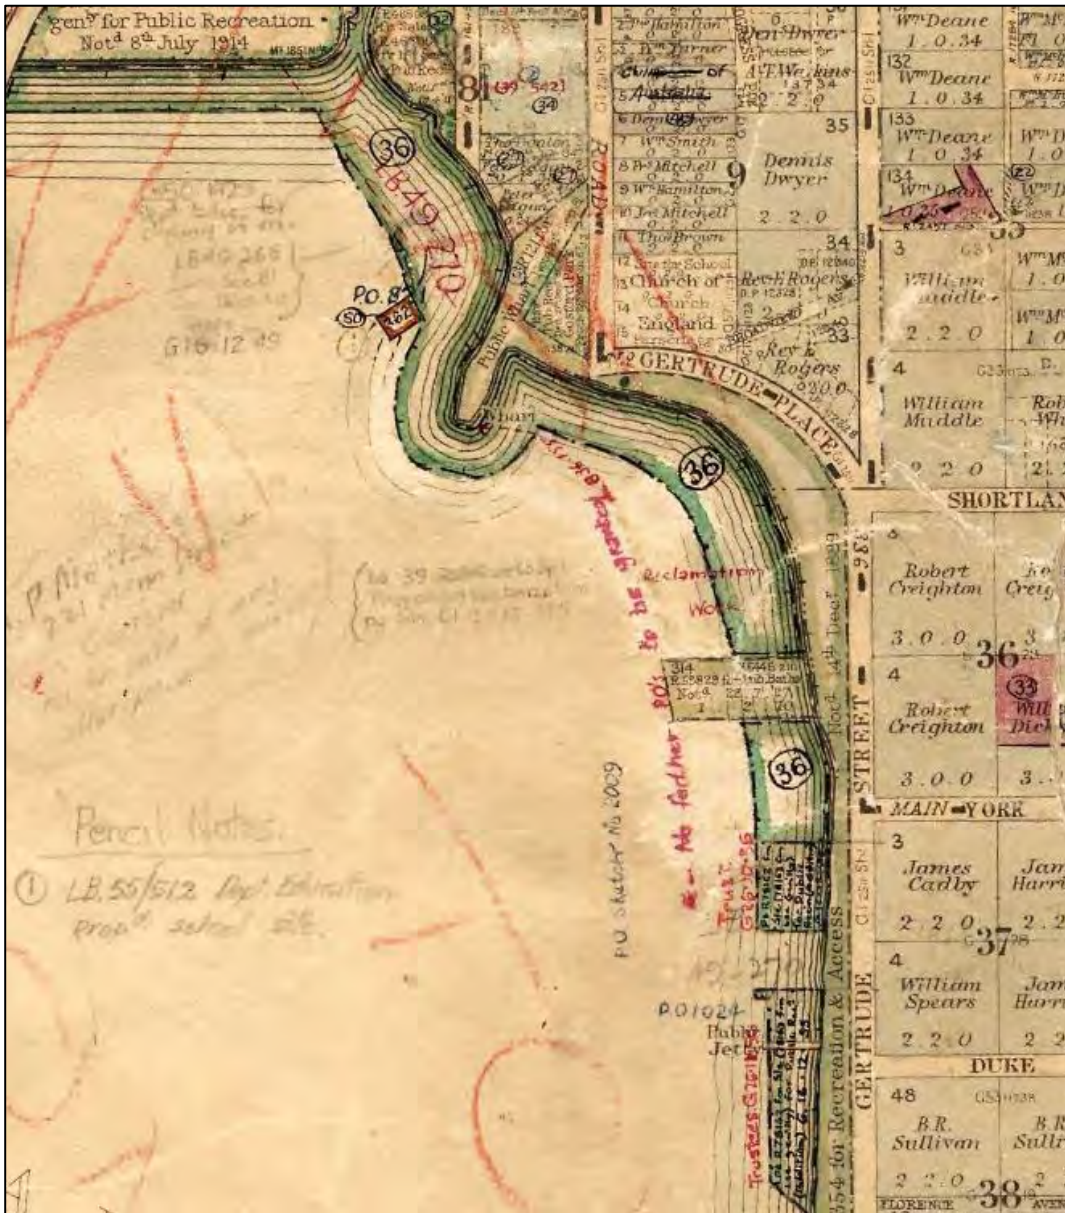
Figure 8: Map of the town of Gosford identifying the former bank and area proposed to be reclaimed (identified as 36 on map). Date of Map 14 June 1934. Image sourced from <https://hlrv.nswlrs.com.au/>, Historical Parish Maps.

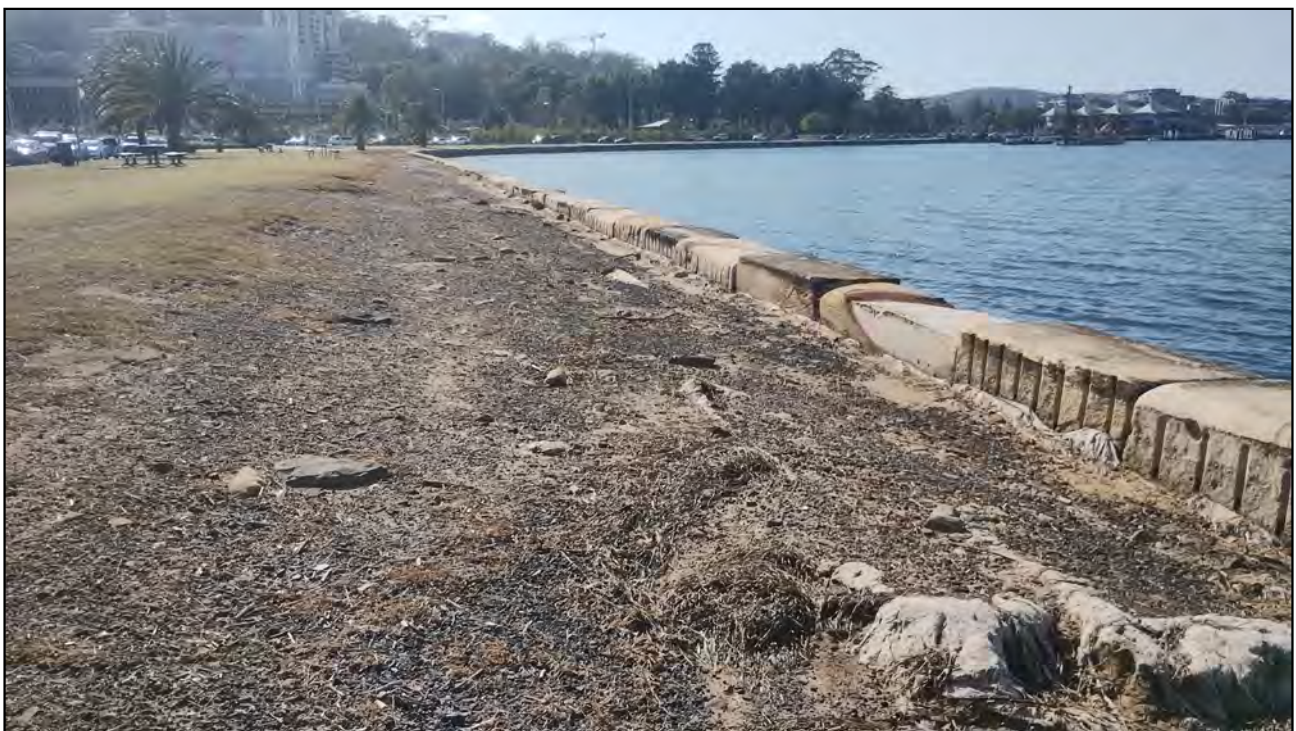
Photo P1-8: Exposed ground surface adjacent the seawall along Graham Park.

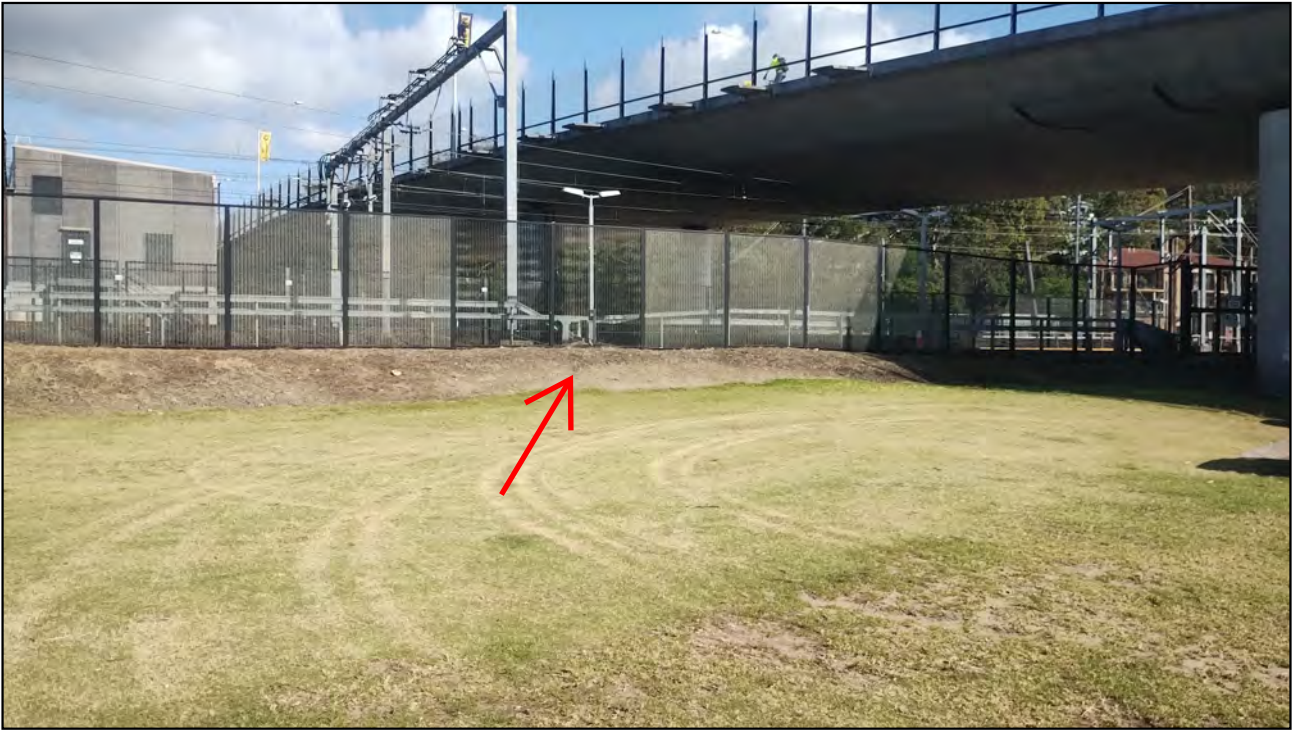
Photo P1-11: North-western portion of Precinct 1. Filled mound in the distance (arrow).

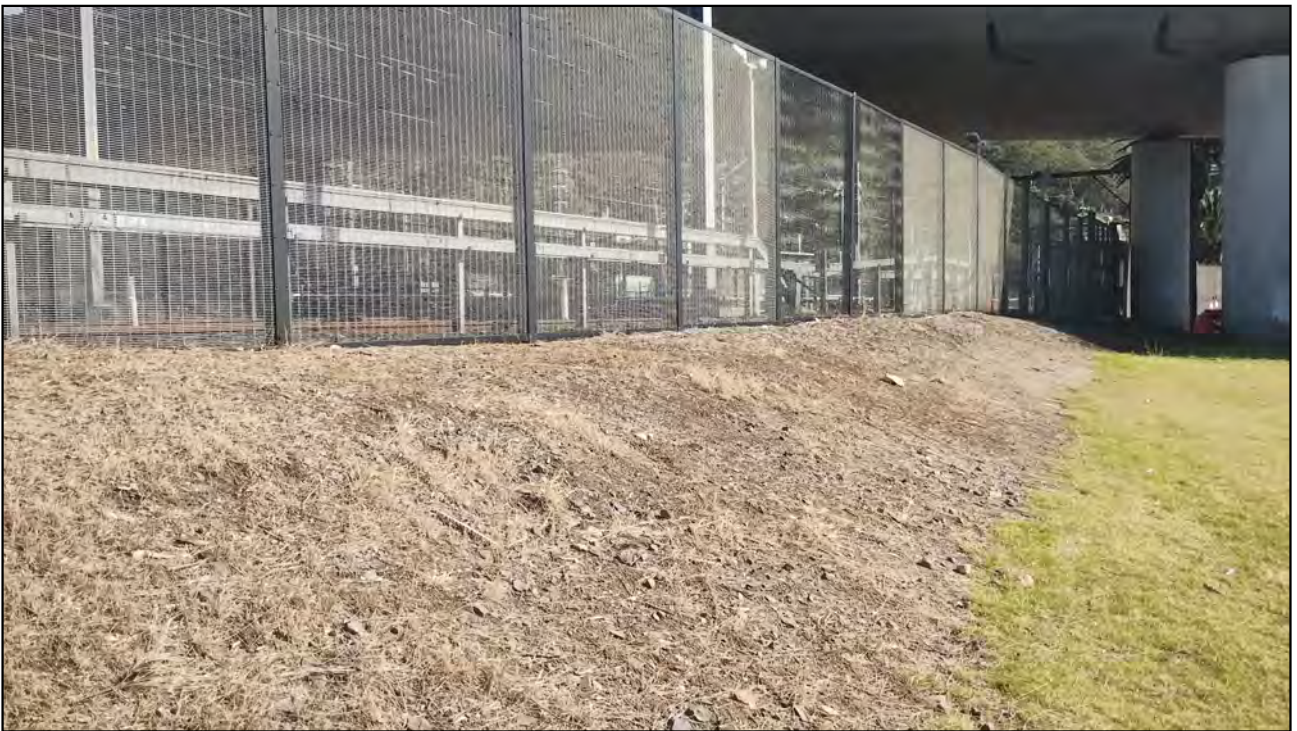
Photo P1-12: Close-up of filled mound along rail corridor.

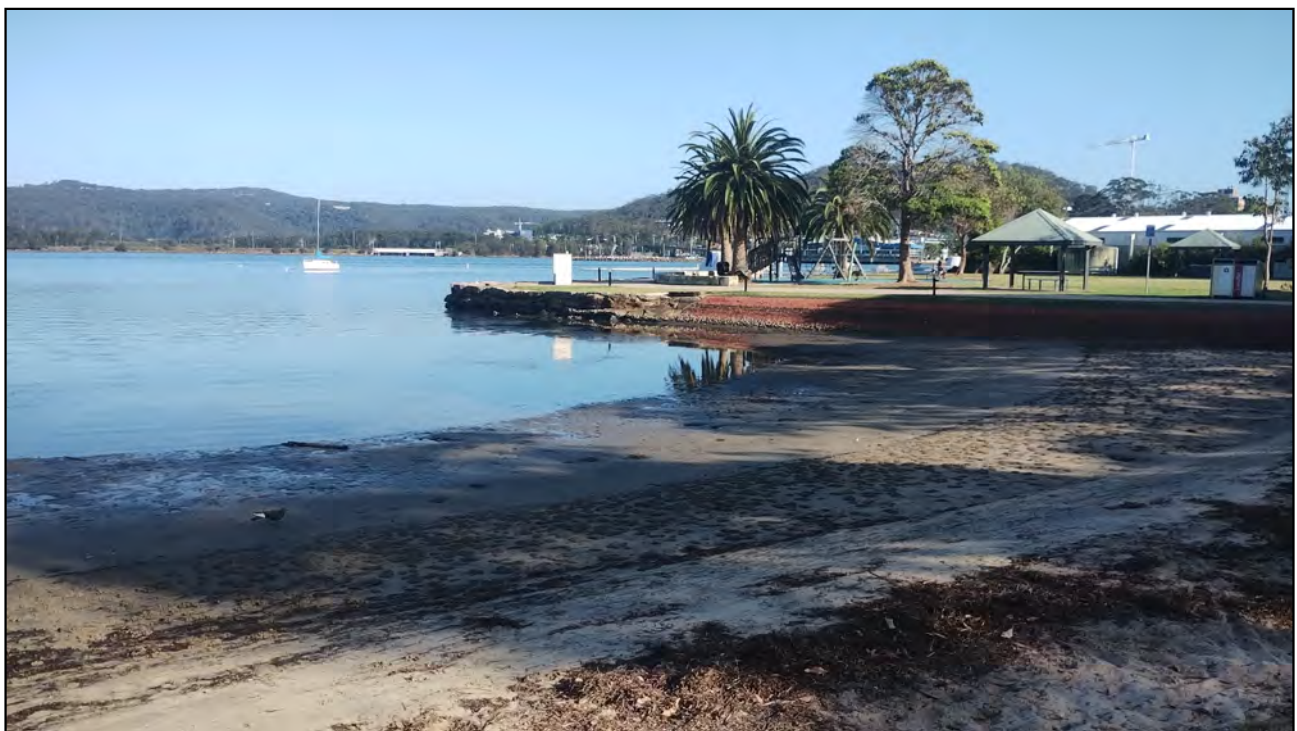
Photo P4-14: Close-up of the waters edge, north of the Gosford Sailing Club.

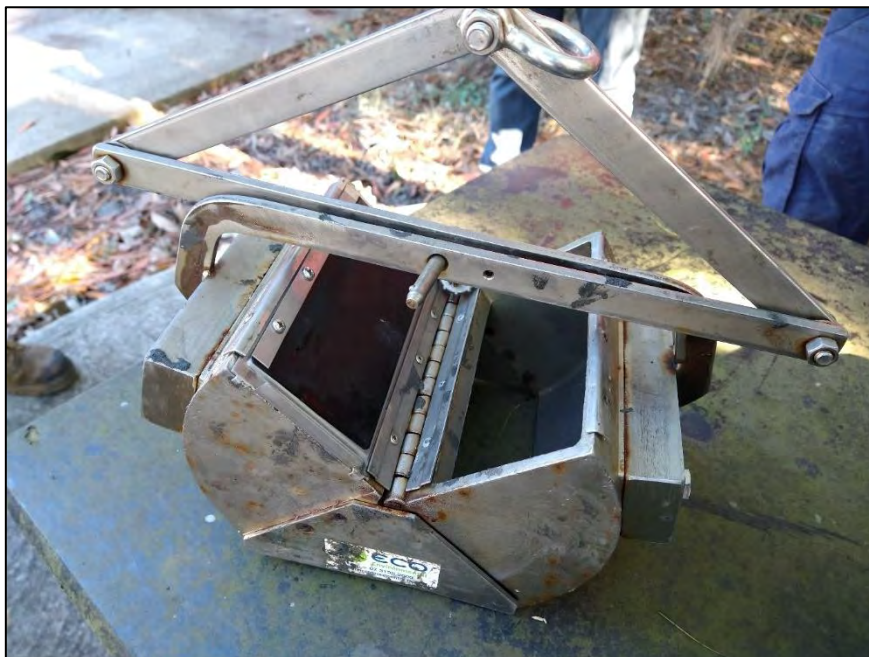
**Figure G1: Petite Ponar Grab Sampler.**

- Collection of samples from sediments (depths of 0-0.1 m) using a Petite Ponar Grab Sampler (see Figure G1 below);
- Use of disposal nitrile gloves to transfer the sample into the sampling jar;
- Recording of field conditions at the time of sampling and sediment properties such as composition, texture / consistency, grain size and colour.
